# Panther Fire Equipment Recovery

## Lessons Shared

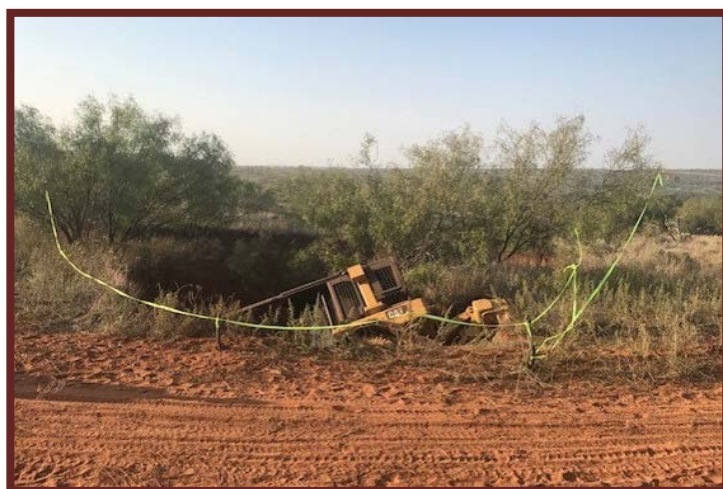
Looking into ravine from fire line

Operator 1 began to dig soil out from under the rippers at the rear of the dozer. This allowed the tracks to contact the ground and eliminate the possibility of the dozer rolling over. After the dozer was sitting level in the bottom of the ravine, Operator 1 began pushing soil into the ravine. This was started behind the dozer to create a ramp that the dozer could be winched up. After the ramp was pushed, Operator 1 positioned their dozer in front of the stuck dozer to push it, blade to blade. Operator 2 hooked the cable from his rear-mounted winch to the rippers of the stuck dozer. Operator 2 then winched the stuck dozer while Operator 1 pushed the dozer safely out of the ravine. The total time from arrival to dozer recovery was roughly 45 minutes.

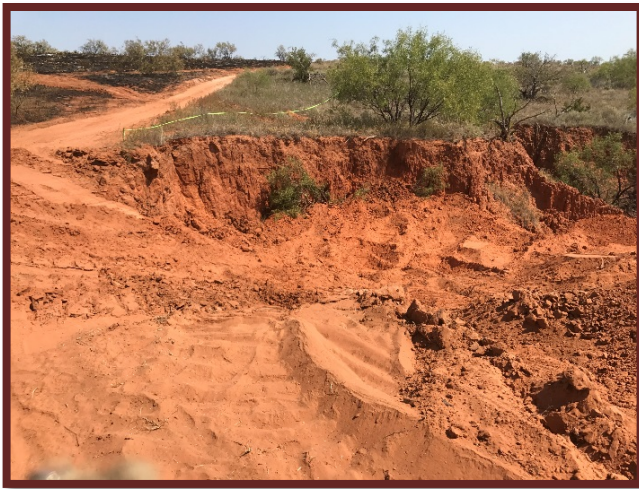
**Looking into ravine after dozer removal**

The dozer was allowed to rest on a level surface for approximately one hour to ensure fluids were not pooled to one side. All fluid levels were then checked, and a thorough walk-around inspection was completed to verify the dozer was safe to start. Once complete, the dozer started with no issues. The dozer was tested by Operator 1. He tracked around and push soil to ensure proper operation. The dozer was then tracked out by a different operator where it was loaded on its transport and taken back to its home unit for a detailed inspection. The only repair needed following the accident was the replacement of a rock guard that had fallen off, which likely was

not caused by this incident. There were also minor scars on the rippers and blade from the recovery operation. The dozer was returned to service on September 22, 2017.

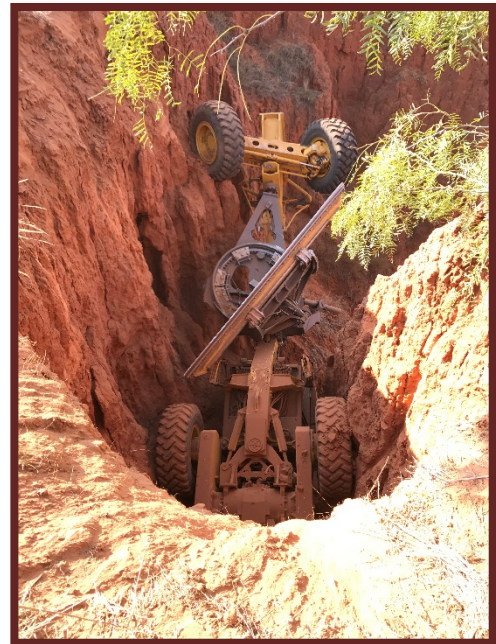
Following the removal of the dozer from the ravine, Operator 2 was requested to assist with suppression operations. Operator 1 moved the type I dozer to the scene of the motor grader accident. The motor grader was upside down in the bottom of a 30-foot deep ravine with both sets of rear tires against the ravine walls. Kent County officials discussed a potential plan with Operator 1 to safely remove the motor grader. The first idea was to order a crane to the accident site and hoist the motor grader from the ravine. This idea was determined to not be feasible due to the remote location of the accident site and poor road conditions that would limit access of a crane. The second recommendation was to hook a cable from the Type I dozer to the front of the motor grader, stand it up vertically, and then pull it out of the ravine. This was attempted, but could not be completed due to the weight of the motor grader.

**Motor grader in ravine, looking down from fire line**

The executed plan was to cut away the north wall (left side of motor grader) of the ravine, next to where the left, rear tires were against the wall. Operator 1 used the Type I dozer to deliberately push soil into the ravine on the north side. Operator 1 used extreme caution working around the ravine rim. After pushing several times toward the edge of the ravine, the wall began falling into the ravine. Operator 1 continued to push down into the ravine, parallel to the motor grader. This created a small wall that remained next to the grader. The wall slowly began to fall into the area where Operator 1 was working, revealing the rear tires. Operator 1 continued constructing a ramp alongside the motor grader, pushing dirt all the way into the bottom of the drainage. Upon completion of the ramp, Operator 1 positioned his dozer in the bottom of the widened ravine perpendicular to the motor grader.

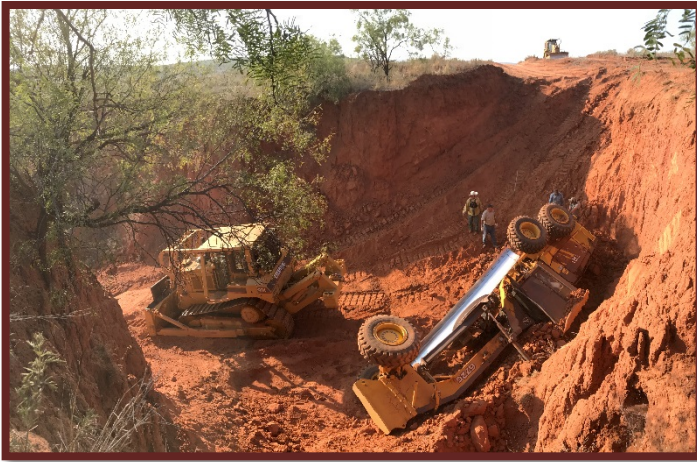
**Type I dozer preparing to roll motor grader, looking into ravine from south rim**

A cable was connected from the back of the dozer to an anchor point on the underside of the motor grader. The motor grader was then slowly pulled from its roof to its left side. The cable was then re-attached to an anchor point higher on the frame of the motor grader. The grader was slowly pulled back on to its wheels. At this time, two Texas State Type II dozers, previously engaged in suppression, stopped at the site to observe the recovery. Due to the location of the grader after up-righting, Operator 1 could not maneuver his dozer to exit the ravine. It was then decided to utilize the

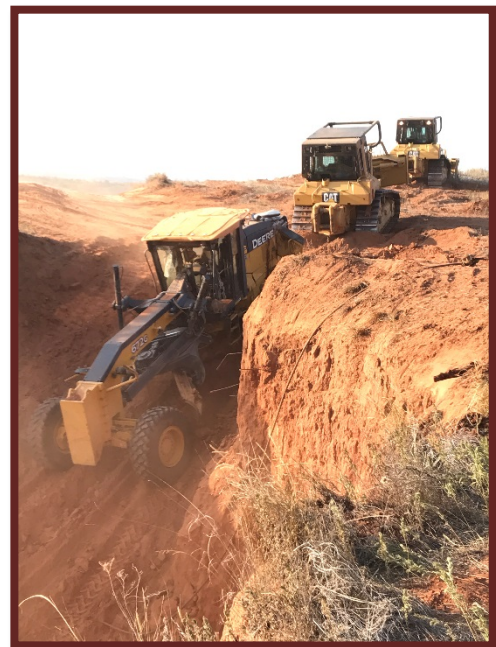
**Two Type II dozers pulling motor grader from ravine**

Type II dozers to winch the motor grader up the ramp from ravine. Due to the inability to start the motor grader, it had to be removed with the brakes engaged. The first dozer connected the cable from their rear-facing winch to the rear of the motor grader. While attempting to winch the grader the dozer was pulled toward the ravine. The second dozer connected their rear-mounted winch cable to the front of the first dozer to act as an anchor. The first dozer then winched the grader to the top of the ravine. Both dozers were then repositioned, and the grader was winched the remainder of the way to the fire line. Total time of recovery for the motor grader was approximately 4 hours.

Once removed from the ravine, the motor grader was allowed to rest on-site overnight. The following day, Kent County contracted a qualified service technician to unlock the brake system on the motor grader. Operator 1 then used the Type I dozer to tow the grader roughly 2 miles to a county transport. County personnel used a second motor grader to push it onto the transport. It was then taken back to a Kent County facility. Upon visual inspection, there was some damage to the engine housing, a broken side window from rolling over during recovery, a broken windshield from the operator using that as an exit point, and some dings on various other parts. The motor grader was not back in service as of the date of this report.
