## Summary

## UTV Tree Strike

### Rapid Lessons Shared

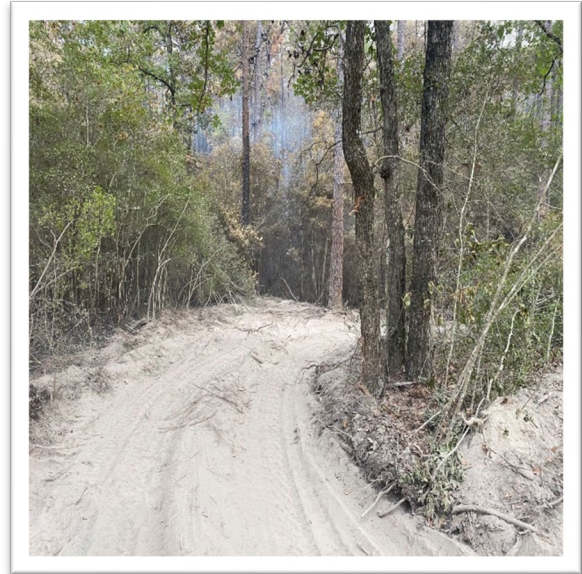
*Dozer Operator's view as he approached the creek*

While tracking down the established dozer line, the area proved to have compounding difficulties related to navigating the correct path. Numerous spot fires had previously occurred along this division creating a “web” of firebreaks. Additionally, dark conditions with no active fire along the fireline and an exceptional amount of dust being stirred up by the tracks of the dozer made it challenging to stay on the correct line. After “getting lost” a few times by selecting the wrong section of line to travel down, the operator asked the swamper to take the lead on the UTV so the taillights could be seen through the dusty conditions, which would help them navigate the fireline until they could reach the active section of the fire.

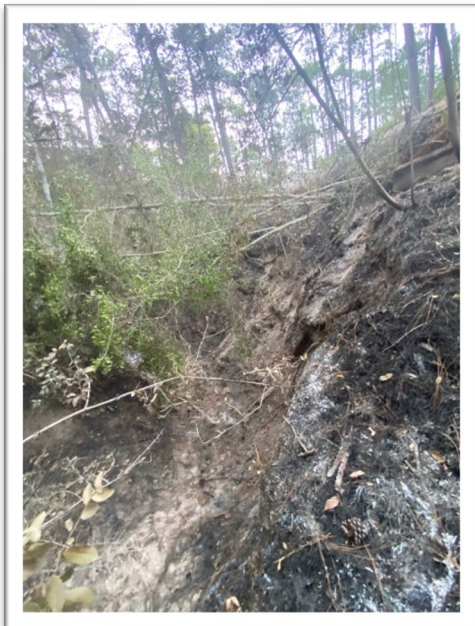
*Photo showing steepness of drop off into creek*

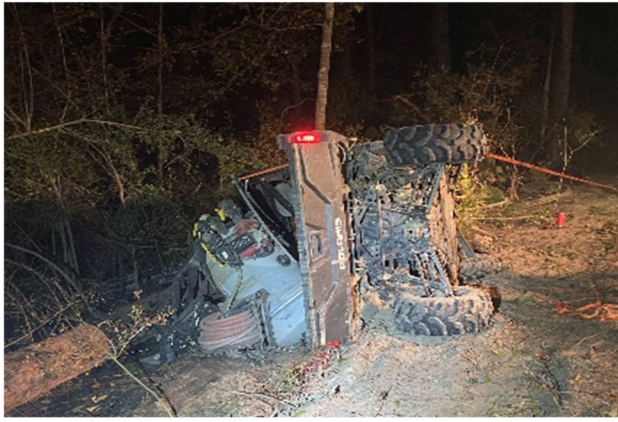
At approximately 24:00, the UTV went downslope towards a creek, making a sharp right turn. The swamper noticed a narrow creek with a steep bank (15-20’ drop) after making the turn and stopped to radio the operator of the hazard. While the swamper was reaching for the radio, he heard a crack immediately followed by the UTV being rolled over by the tree strike.

*UTV immediately after tree strike*

The operator had lost visual of UTV lights after the UTV went downslope. He progressed downslope and made the sharp right; DZ1 inadvertently sheared a 16-inch Diameter at Breast Height (DBH) 100-foot-tall pine tree. The operator did not feel the dozer shear the tree but saw the tree fall in front of DZ1. He looked out and saw the taillights of the UTV turned vertically and immediately got out to assess the situation.

Climbing down, the operator saw that the tree had landed on top of the UTV and flipped it over on its side. He checked on the swamper and discovered that he appeared to be uninjured, although his foot was caught in the UTV. The operator assisted the swamper with removing his boot, which freed him from the UTV. After regrouping, the ICT3 was notified of the incident. The ICT3 checked on the firefighters, and after determining that they were safe, made the proper notifications to agency administrators around 00:23. The swamper and operator were able to drive the UTV back to the DIV Alpha/Zulu break and both were released for the evening. Both returned to the fireline the next day.

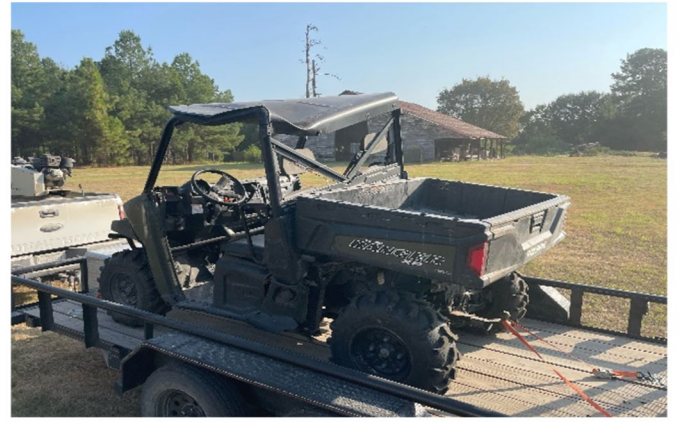
*Damaged UTV after recovered from fire*
