## Summary

## UTV Tree Strike

### Rapid Lessons Shared

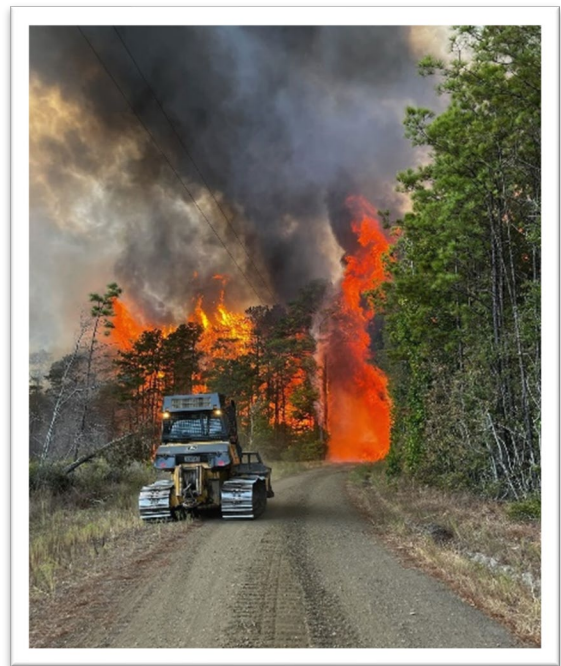
*Shearwood Creek Fire - August 24, 2023*  
*Photo Credit: Bobby Kiskin*

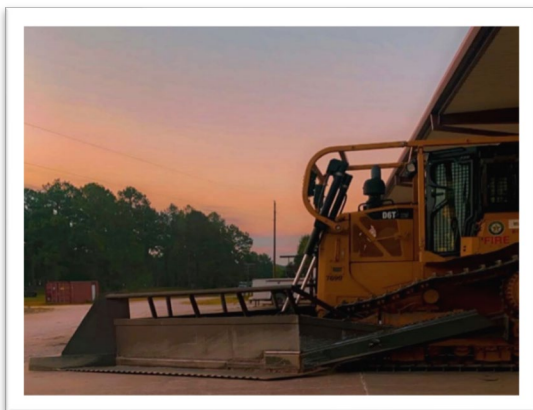
*Caterpillar D5T with shear blade*

The fire was transitioned to a Type 3 incident at 14:00. Following the transfer of command, the ICT3 requested a Type 1 Dozer equipped with a shear blade (DZ1). This specialized piece of equipment has the ability to rapidly establish fireline in pine timber fuel models by shearing large diameter pines with a large fixed ‘V’ blade (13.6’ wide and 20’ long) with cutting edges along the bottom. This resource was staffed by a qualified Initial Attack Dozer Operator (DZIA) and a swamper, qualified as FFT2, on a UTV.

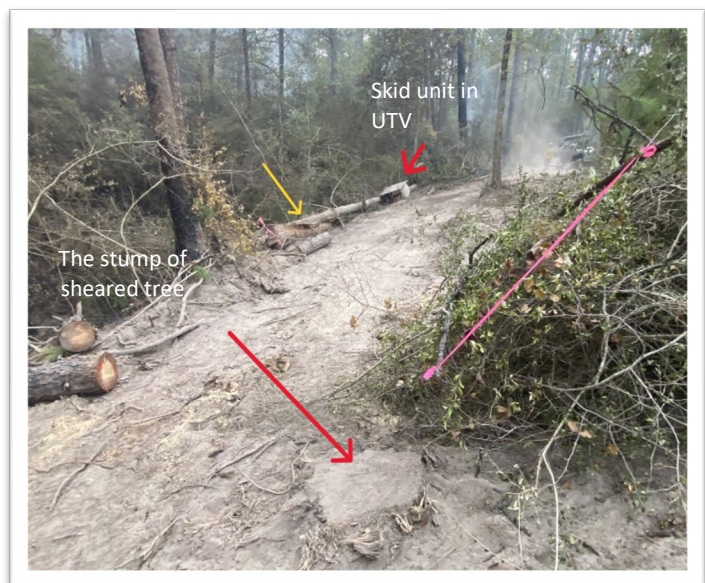
The operator had lost visual of UTV lights after the UTV went downslope. He progressed downslope and made the sharp right; DZ1 inadvertently sheared a 16-inch Diameter at Breast Height (DBH) 100-foot-tall pine tree. The operator did not feel the dozer shear the tree but saw the tree fall in front of DZ1. He looked out and saw the taillights of the UTV turned vertically and immediately got out to assess the situation.

Climbing down, the operator saw that the tree had landed on top of the UTV and flipped it over on its side. He checked on the swamper and discovered that he appeared to be uninjured, although his foot was caught in the UTV. The operator assisted the swamper with removing his boot, which freed him from the UTV. After regrouping, the ICT3 was notified of the incident. The ICT3 checked on the firefighters, and after determining that they were safe, made the proper notifications to agency administrators around 00:23. The swamper and operator were able to drive the UTV back to the DIV Alpha/Zulu break and both were released for the evening. Both returned to the fireline the next day.
