Pipeline Rupture Rx Burn

Rapid Lessons Shared

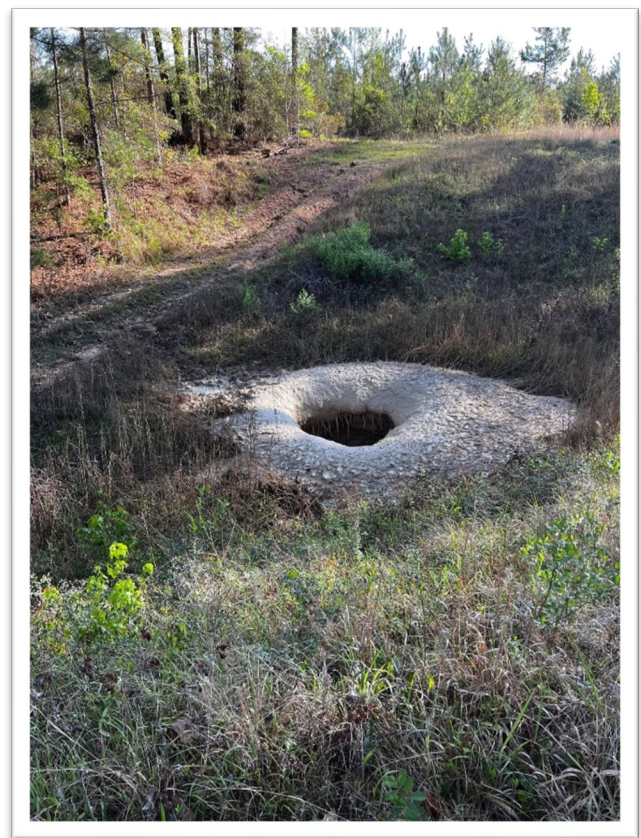
Texas A&M Forest Service resources from the Livingston District Office had planned for a prescribed burn on March 20, 2023. That morning, an operator with a Caterpillar D5 tractor plow and the Burn Boss arrived on scene to do some final prep work to ensure containment lines were adequate and the unit was ready for the burn. The operator was refreshing a containment line along the edge of a pipeline right-of-way on the north side of the burn unit, back-dragging his blade to minimize soil disturbance. As the operator worked, he noticed a large hole in the ground, about 2 feet in diameter, surrounded by dirt in an area where the right-of-way dipped into a low drainage. The operator stopped about 50 feet away and called over the radio to the burn boss, describing what he was seeing. The burn boss walked over to the area to investigate. From the ground, the burn boss could hear what sounded like rushing water, which was caused by water in the hole from previous rainfall and the gas leaking from the pipeline. The sound could not be heard from the cab of the dozer.

Once the hole was identified as a ruptured pipeline, the burn boss took a quick photo and brief video for training purposes, and he and the operator cleared the scene. Once they were in a safe area, they immediately called the emergency pipeline number from one of the markers in the right-of way. A pipeline representative arrived within an hour and shut down the line. The line that had ruptured was identified as a 12-inch diameter natural gas pipeline that was approximately 10 feet deep at the point of the rupture. The cause of the rupture is unknown.

After the pipeline was shut off and the scene was secured, all personnel returned to their office. Pipeline crews returned at a later date, and the pipeline was safely repaired within a week of the incident. After the pipeline was repaired, the prescribed burn was never conducted due to lack of favorable weather conditions.
